User's Guide

Replacing Ceilometer Laser Transmitter CLT321

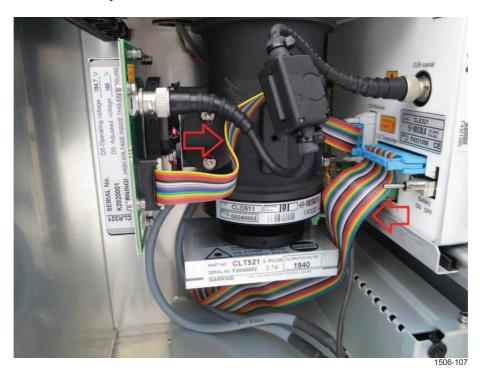
Figure 25 Routing RX and TX Flat Cables

To avoid interference, make sure that you keep the RX flat cable and the TX flat cable apart.
